# BOILER ENGINEERING REPORT

## PENNSYLVANIA RAILROAD N° 1361

*EXCERPT*

October 12, 2020

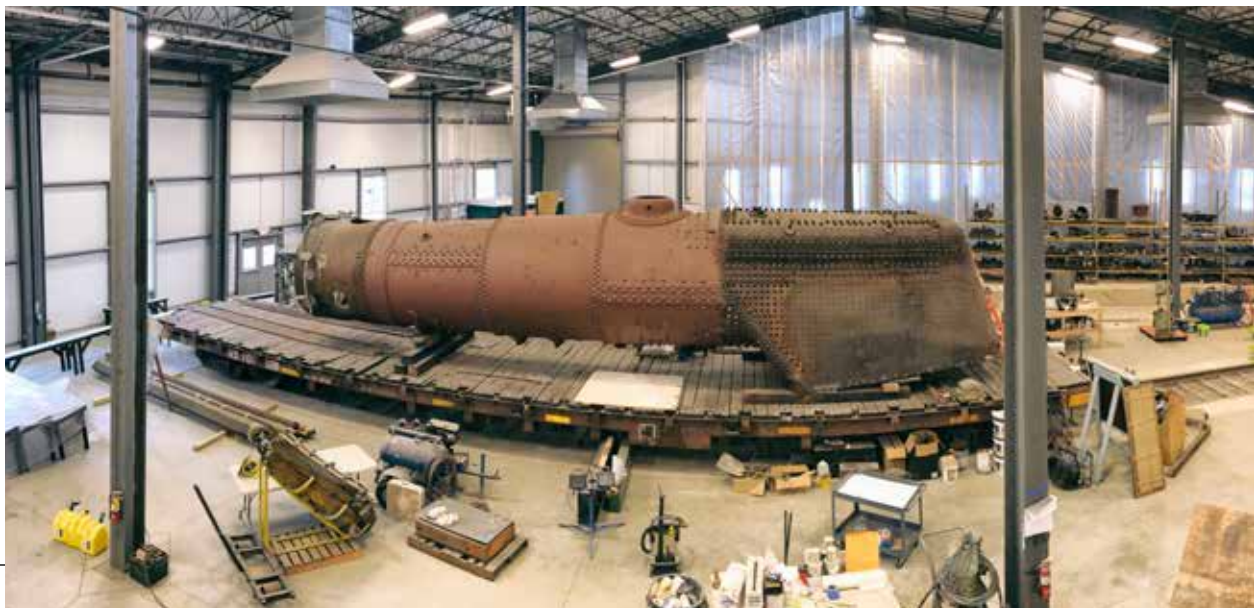
Substantial replacement portions of the side sheets have been fabricated and partially installed. However, the workmanship on these items was marginal with noticeable welding warpage and inaccurate placement of staybolt holes. The two upper, extreme-most backhead braces were also fabricated new and replaced.

**ABOVE:** The boiler of No. 1361 as FMW first inspected it in December 2019

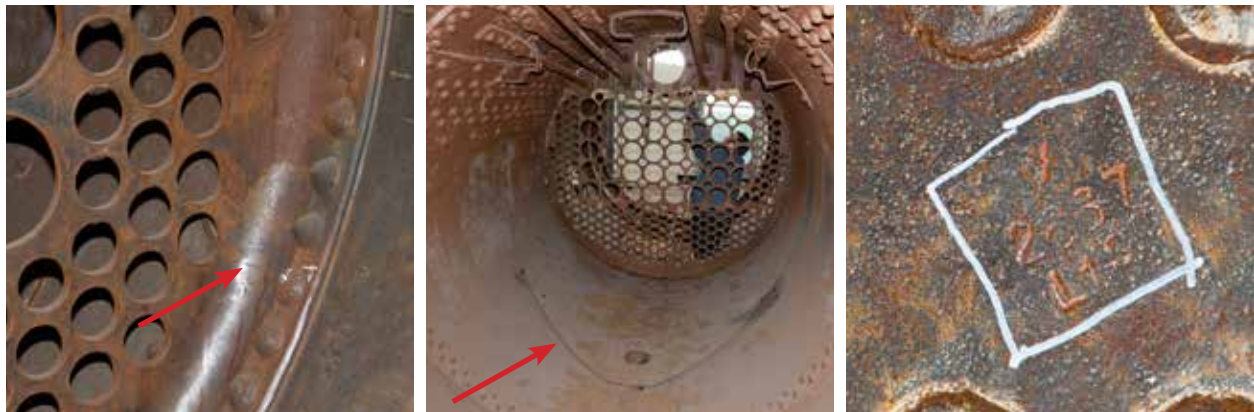
The first barrel section on the K4s boiler is a very short, non-tapered course that consists of the front flue sheet and is riveted to the smokebox and the first course. The flue sheet in No. 1361 had a welded patch installed in the early 2000s. This patch consists of approximately the bottom sixth of the flue sheet, which was a common place for corrosion on steam locomotives given the difficulty of removing the mud and scale around the bottom knuckle during boiler washes [SHOWN BELOW LEFT AND ON PAGE 5].

Finally, FMW noticed that the front flue sheet appears to be stamped for L1s locomotive with boiler No. 2637 [SHOWN BELOW RIGHT]. The PRR L1s 2-8-2 locomotives had (nearly) identical boilers to those of the K4s, thus FMW surmises that the flue sheet was placed into this boiler during an overhaul sometime during the steam era. It might have been slated for installation in the 2-8-2 but was installed in this boiler to expedite a previous PRR overhaul.

- RIVETS
  - Replace all rivets identified with the LIDS machine as being of improper metal when installed between 1996 and 2007, including those that hold the bottom of the front flue sheet in place

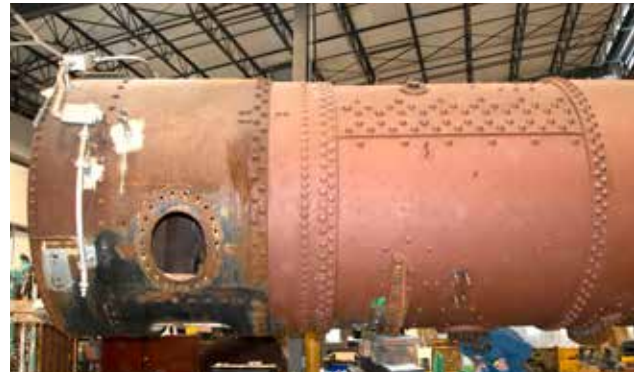
The first course of the boiler contains three washout plugs, positioned approximately at the 2 o'clock, 6 o'clock and 10 o'clock positions. The bottom of the first course contains a large doubler plate that corresponds with a large front boiler waist sheet brace [SHOWN ABOVE CENTER AND AT RIGHT]. The majority of the front flue sheet braces are riveted to this boiler course, except for the top two most front flue sheet braces. This tapered course appears to be in sound condition, with no visible exceptions noticed.

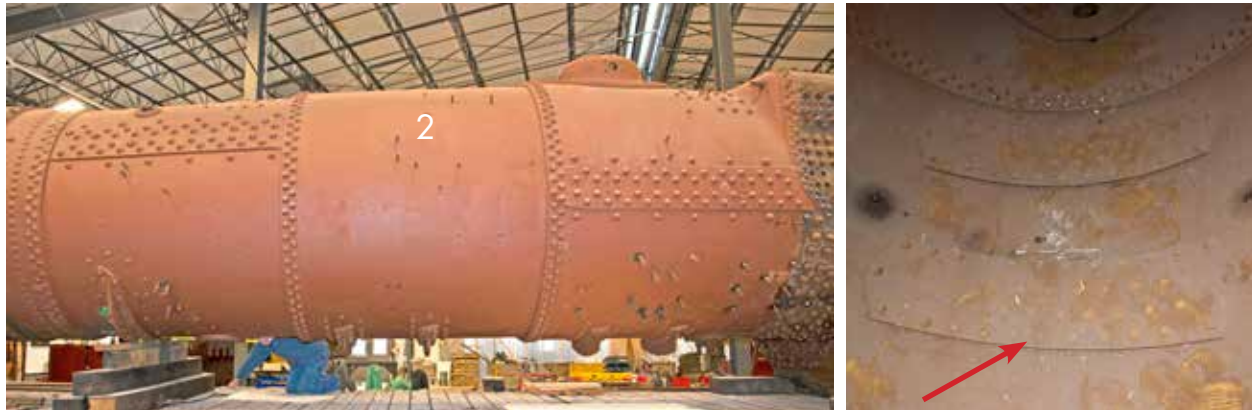
The second course of the boiler is a tapered course. It contains neither washout plugs nor openings. The two middle-most front flue sheet braces are riveted along the top of this boiler course, and it also contains two additional waist sheet support brackets along its bottom [SEE BELOW LEFT]. It appears a few of the rivets attaching the waste sheet supports to the course have been replaced [SEE BELOW RIGHT].

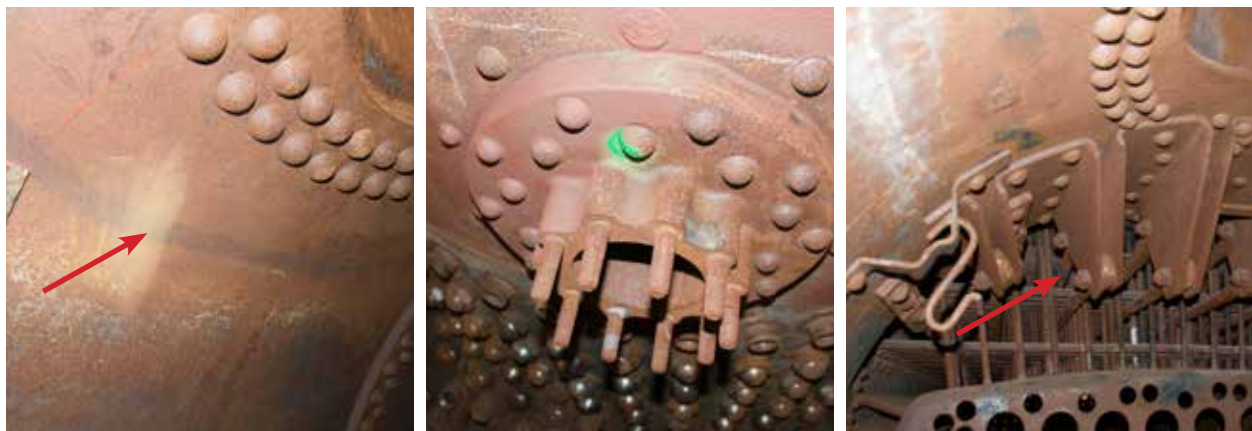
The photographs below show the steam dome flush patch [ARROW] with new dome rivets and weld repair [BELOW LEFT], the bottom washout plug [BELOW MIDDLE] and the back head brace bracket array [BELOW RIGHT].

One particular item requiring FRA review and acceptance is the status of the third course dome flush patch repair. As referenced in Section 1, there was a substantial amount of work, and re-work, attributed to this flush patch. We have included copies of FRA correspondence available on hand at the RMM in APPENDIX E as well as copies of relevant additional dome patch information. FMW believes that the dome patch has been repaired appropriately, with all necessary supporting documentation, but recommends final FRA review of the documentation regarding this repair and the supporting documentation to confirm acceptance of the repair.

- THIRD COURSE FLUSH PATCH
  - Verify that FRA accepts the repair documentation and the status of the existing repair
  - If required by FRA, retain an NDT firm to re-x-ray the welds to verify their integrity

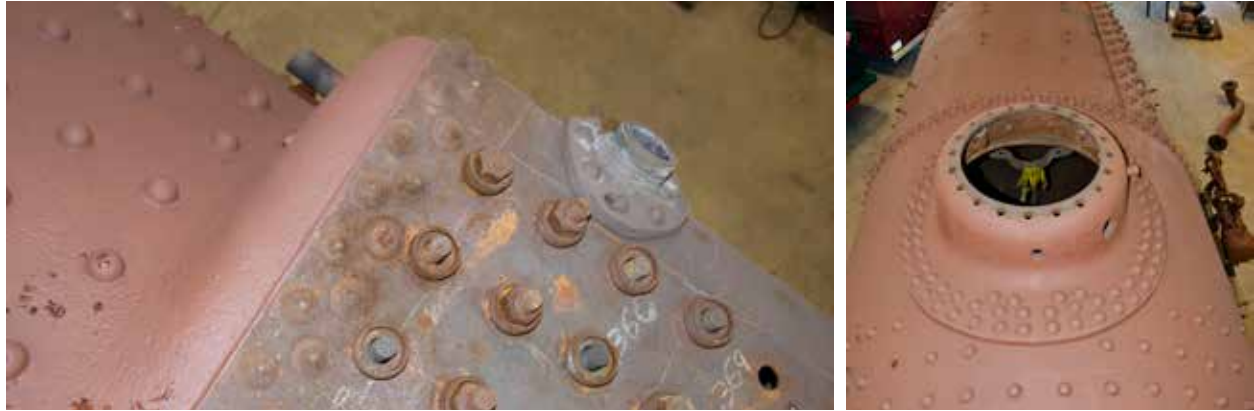
The following two photographs show the view of the top of the boiler, including the transition from the boiler barrel to the roof sheet [BELOW LEFT] and general view along the top of the boiler [BELOW RIGHT].

The photograph ABOVE LEFT shows the right hand top corner of the roof sheet where it intersects with the third course. The third course steel was originally 1" thick and the "hip" corners were flanged into the "square" shape. The roof sheet of the firebox, which is somewhat gray in appearance in this photograph, was originally designed to use 3/8" thick steel, but the PRR replaced the original roof sheet with in 1939. Given some of the UT readings we have taken, which are well above .375" in thickness, our understanding is that PRR replaced the original 3/8" sheet with 7/16" thickness (0.4375") plate. We will address this further in the following section of this report. The photo ABOVE RIGHT shows the field of back head brace bracket rivets (bottom) as well as the new dome rivets. These rivets were tested during FMW's NDT inspection to verify their metallurgical composition.

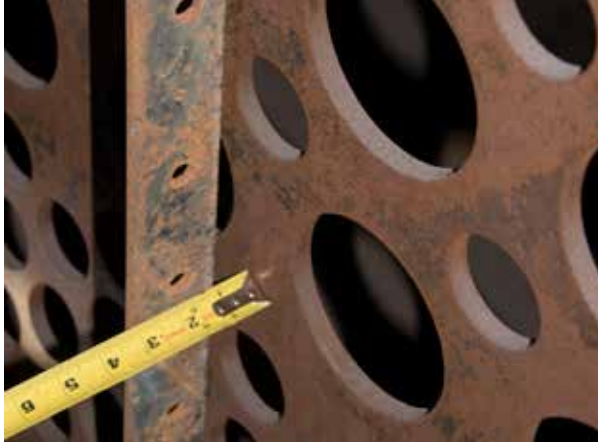
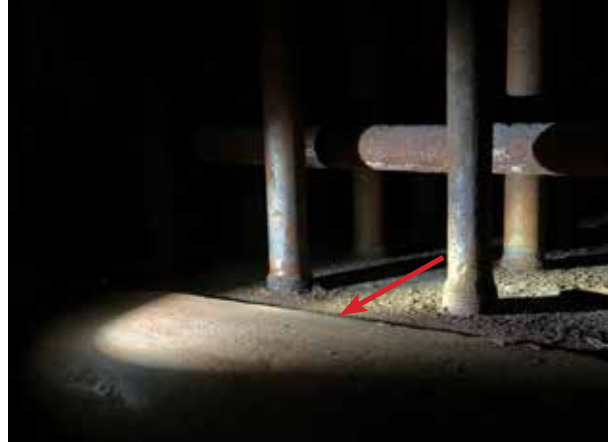
#### **2.1.4.1 Rear Flue sheet**

The rear flue sheet of No. 1361 was fabricated and installed circa 1999. FMW notes this flue sheet is bowed approximately one inch along its vertical axis as a result of improper bracing during fabrication / installation [SEE BELOW LEFT]. FMW also noted that there is substantial “mismatch” or “high-low” at the weld seam between the flue sheet and the crown sheet [SEE BELOW RIGHT]; this will need to be repaired during the restoration.

- REAR FLUE SHEET
  - The rear flue sheet, while of new construction, was found to be warped and improperly fit to the crown sheet
  - Note that the ASME code in this case requires that the mismatch in height between plates not exceed 0.125 inches [PW-9.3.1]
  - Remove, straighten, heat treat, correct alignment issues, reinstall

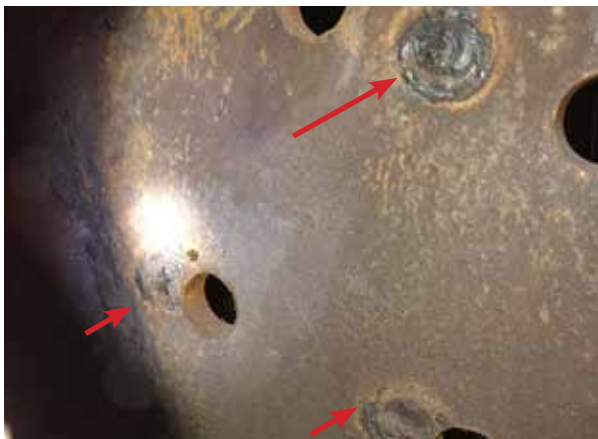
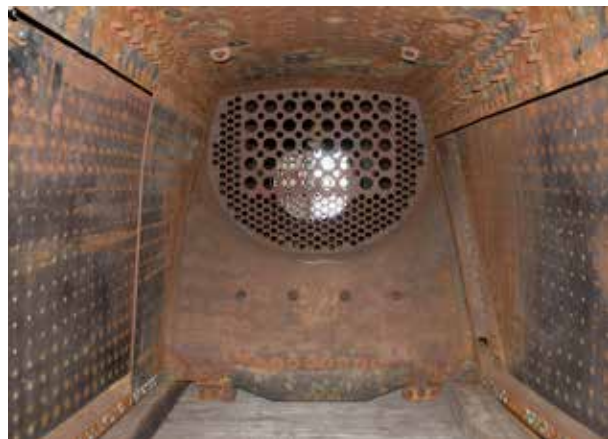
#### **2.1.4.2 New Inside Side Sheets**

The original inside side sheets from No. 1361 were removed and only a small replacement portion of the front left inside side sheet has been installed. The photograph BELOW LEFT shows areas where the installed portion of the front left side sheet was improperly drilled for staybolts, requiring the incorrect bolt holes to be welded up. The photograph BELOW RIGHT shows the cut out portions of the inside side sheets. FMW also identified issues with lack of weld penetration where the left hand side sheet was welded to the existing throat sheet. This will need to be addressed during the restoration.

In the early 2000s, a substantial portions of the mud ring was removed and replaced. This consisted of a “U-shaped” portion of the mud ring extending from the furnace bearer supports at the throat sheet around the entirety of the firebox. The material making up the mud ring repair was full penetration butt welded at their joints. Some of the new mud ring can be seen in the RIGHT HAND PHOTO ABOVE.

- FIREBOX SIDE SHEETS
  - Replace both left and right sheets in their entirety
  - SA516-70 material; 0.4375" thick
  - Replace all staybolts

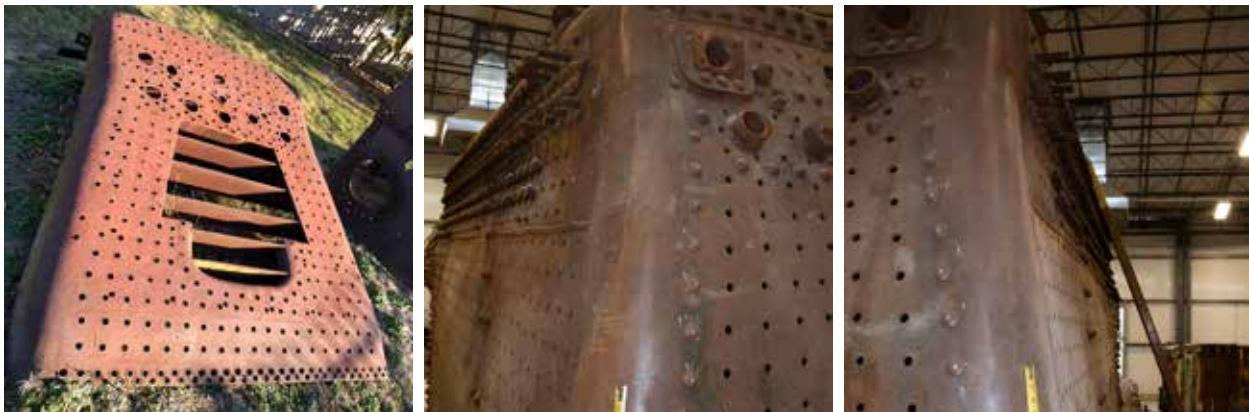
#### **2.1.4.5 New Back Head**

The new back head has been installed on the boiler, including riveting all of the brace connections. As with the door sheet, we had this material tested to verify composition with the MTRs on file during the follow up inspection. The photographs BELOW show the old back head [LEFT], and the new back head [MIDDLE AND RIGHT].

- Remove existing back head
- Modify to include "U" shaped FLANNERY bolt pattern of one-inch "D" type bolts and "UW" or "FW" sleeves [RIGHT]
- This will help to minimize staybolt breakage given the more frequent heating/cooling cycles of steam locomotives in intermittent service.
- Stress relieve
- Reinstall back head

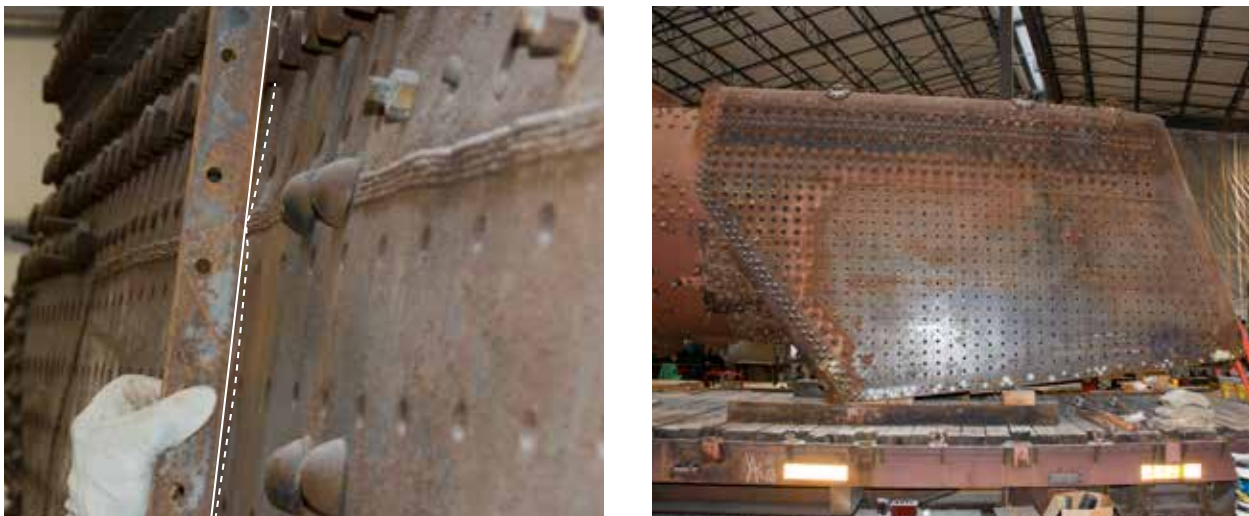
#### **2.1.4.6 New Outside Side Sheets**

New outside side sheets have been installed on the boiler. FMW noticed some dishing of the side sheets near where they intersect with the existing “BELPAIRE” sheets on the boiler and where the back head brace brackets were riveted. This is most noticeable on the left hand side of the boiler, as shown BELOW LEFT in the vicinity of the weld seam between the new and old side sheet. Shown BELOW RIGHT is the new left outside side sheet.

- WRAPPER SIDE SHEETS
  - Replace both left and right sheets from forward rivet seam to back head weldment; from mud ring rivet seam to “BELPAIRE sheet”
  - Modify flexible staybolt pattern to better reflect the FLANNERY pattern using one-inch “D” type flexible stay bolts and “UW” sleeves
  - New wrapper side sheets should be fabricated of 0.4375 inch thick SA516-70 material for strength and compatibility with the existing 79 KSI replacement back head.

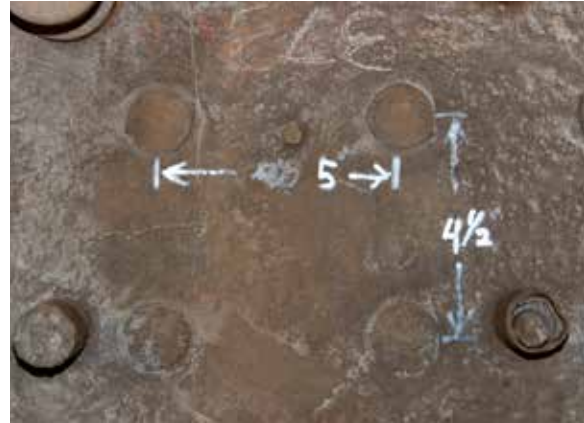
The roof sheet appears to be the most problematic design feature of the K4 boilers. It features a variable staybolt pitch (spacing) as wide as 5.125” in one direction [RIGHT], which is an issue given staybolt diameter and boiler pressure. FMW outlines an engineering solution to this issue in Section 4 of this report.

- Replace the wrapper roof sheet
- Modify current "U" shaped pattern of flexible staybolts with two additional rows at hip end using one-inch type crown bolts with tapered threads at the crown sheet, "KN" nuts, and "URW" sleeves [RIGHT]
- Rigid crown bolts to be up-sized to one-inch type bolts with tapered threads at the crown sheet.
- New wrapper roof sheet should be fabricated of 0.4375 inch thick SA516-70 material for strength and compatibility with the existing replacement back head.

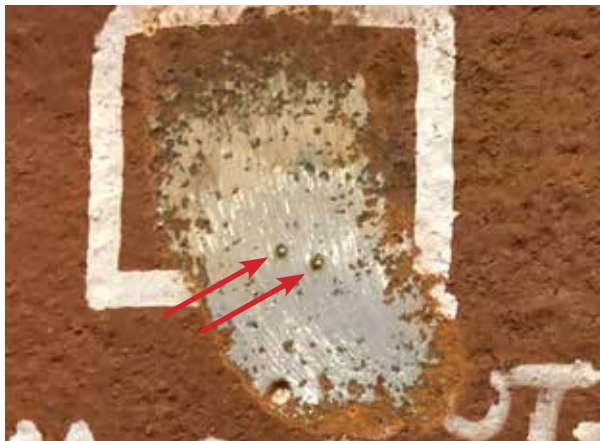
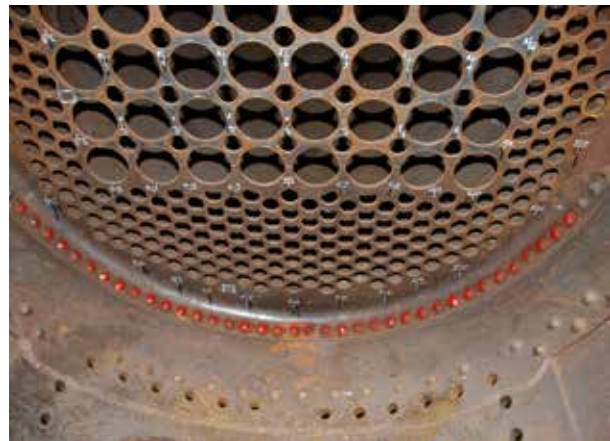
The photographs ABOVE show the laser etchings from the tests [LEFT] and some of the rivets marked for replacement due to carbon content being too high [RIGHT].

material of the proper specification and certifications. This is due to the high level of carbon content in some, but not all, of the new rivets which, in some cases, was nearly twice the permissible amount. This high carbon content results in rivets being too brittle for reliable or safe use. The defective rivets have been marked for removal.

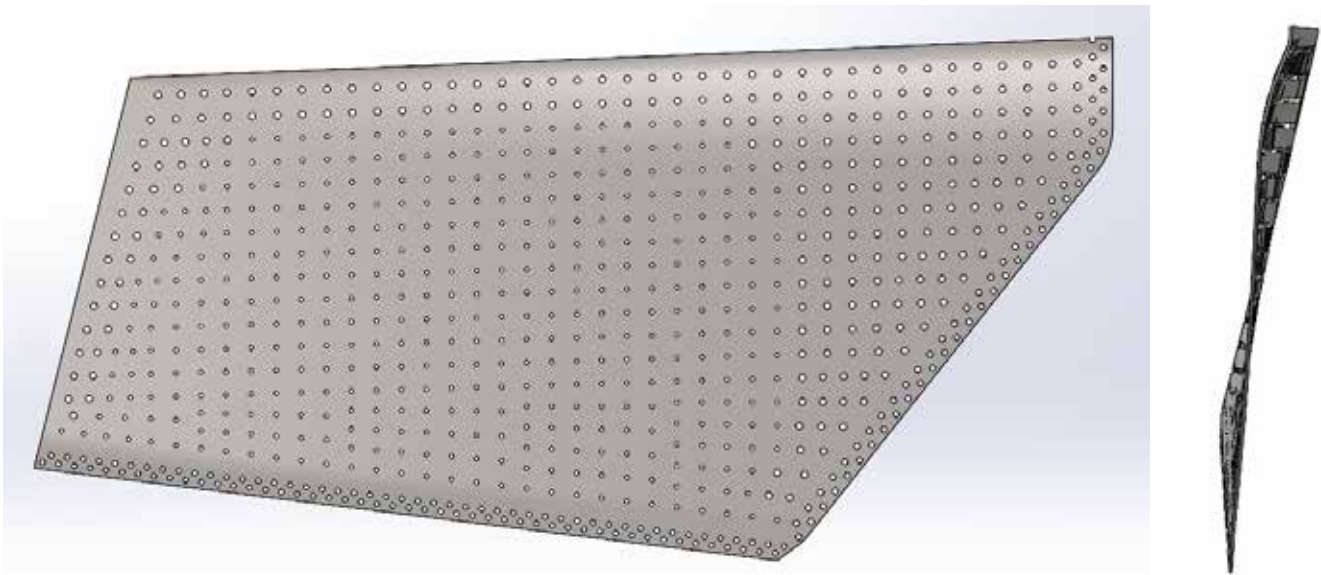
The following graphics speak to the relative complexity of the fabrications associated with the repair, and speak somewhat to the quality issues evidenced in our visual inspection of the locomotive. Shown BELOW is the right hand side sheet from the locomotive. In elevation [BELOW LEFT], this appears to be a flat sheet, but in section [BELOW RIGHT], the “twisted” profile of the sheet is clearly evident.

FMW has outlined its proposed approach to returning the firebox to a state of good repair in Section 4. In brief, the repair will involve the replacement of much of the firebox, save for the mud ring, back head, door sheet, inside throat sheet, and rear flue sheet. By renewing the roof sheet to a thickness of 7/16” and utilizing 1” diameter staybolts throughout, the issues associated with geometry and spacing of the crown stays will be resolved.

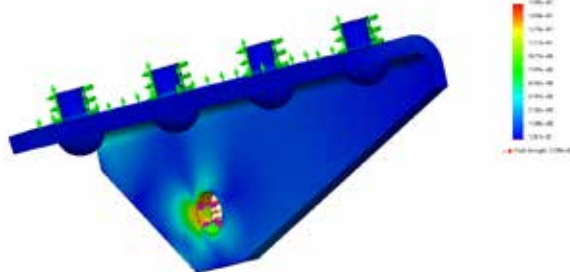
BASELINE

Bracket G can be modified to meet the safety factor by welding on a stiffener plate, but it can use the same, original riveted connection. Below are graphic readouts of the FEA.
