# BOILER ENGINEERING REPORT

## PENNSYLVANIA RAILROAD N° 1361

*EXCERPT*

October 12, 2020

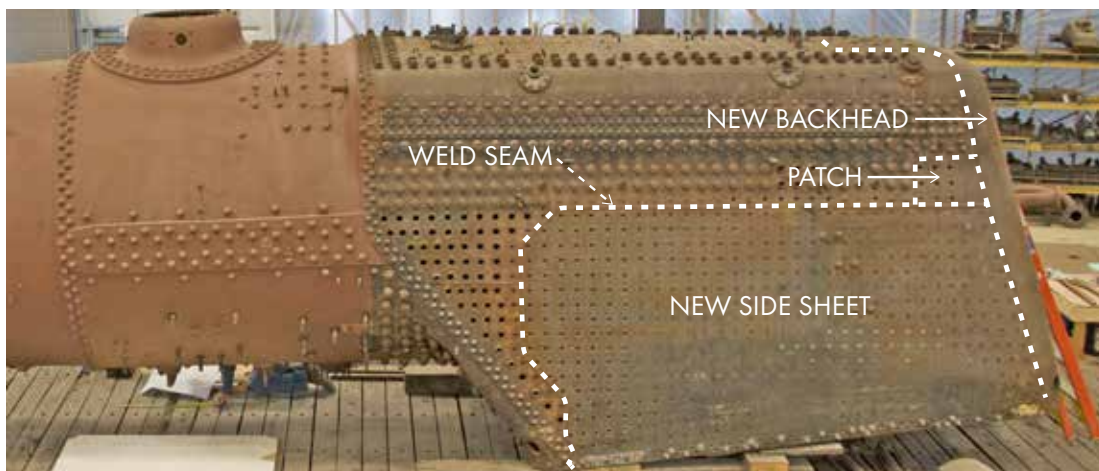
The firebox of No. 1361 has been modified significantly since 1985. These modifications include: 1) a new rear flue sheet; 2) new portion of the front left inside side sheet (partially completed); 3) new portion of the mud ring; 4) new door sheet (uninstalled); 5) new back head and rear portion of the roof sheet; 6) new outside side sheets (partially installed); and 7) an outside throat sheet patch. The photograph BELOW shows the new portions of the outside of the firebox – the modifications are mirrored on the other side of the boiler. The crown sheet, inside throat sheet, BELPAIRE sheet, and majority of the roof sheet are original to the PRR.

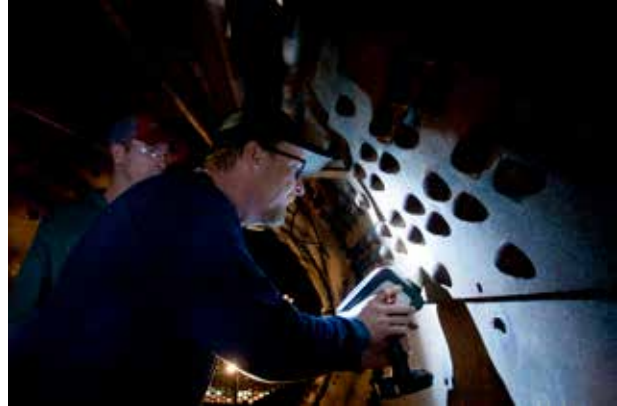
On Monday, January 27, Wolf Fengler and FMW Subcontractor WORLD TESTING, INC. (“WTI”), arrived on site to begin the testing and data entry. WTI first undertook two days of LIBS work. This hand-held spectrometer is able to determine the chemical composition of materials, outlining percentages of key components, such as percent carbon. The photo ABOVE shows the small “Z-Analyzer” at work using LIBS technology to test boiler sheets.

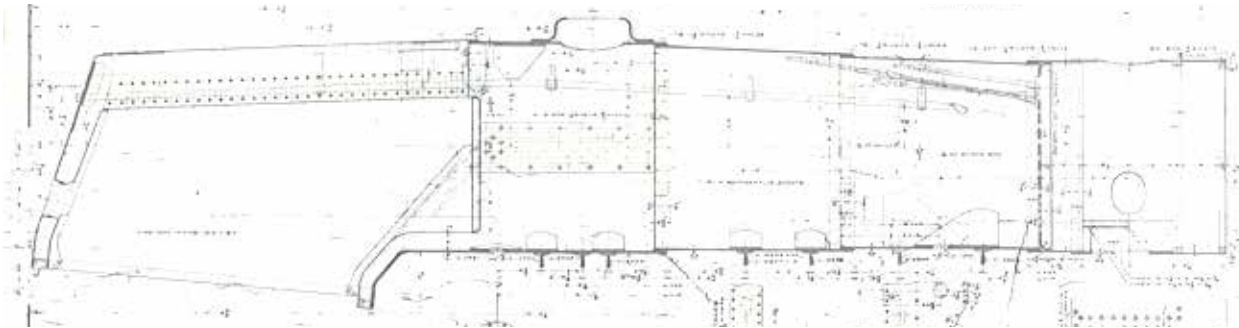
The barrel of No. 1361 consists of three main cylindrical courses and one short cylindrical course adjacent to the smokebox. The boiler consists of a typical tapered barrel, save for the third course, which includes a transitions into both the throat sheet (bottom) and the hip / BELPAIRE sheet at the top. A boiler elevation drawing is included BELOW:

From an engineering perspective, the original boiler barrel is in sound condition. This is due to the known materiality of the boiler barrel materials, the remaining thickness, and the repairs made on the boiler to-date. As referenced in Section 4 of this report, FMW will propose a series of relatively minor repairs to the barrels (e.g. replacing rivets that have too high a carbon content and changing washout plug types), but the overall condition of the barrel is sound.

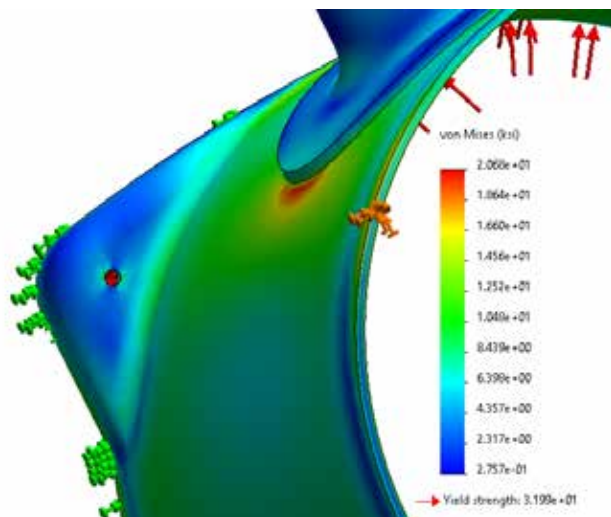
FMW has performed limited finite element analyses (“FEA”) of some boiler components, including the stresses associated with the dome course and its transition to the hip [SHOWN AT RIGHT]. These calculations indicate that all stresses are well below the maximum afforded in the CFR. The FMW Team has also undertaken a study of the stresses internal to the back head brace brackets [REFER TO SECTION 3.3]. Unlike most locomotives, where back head braces are riveted to the boiler barrel / wrapper sheet, the back head braces on No. 1361 are connected to riveted brackets, between one and three braces per bracket.

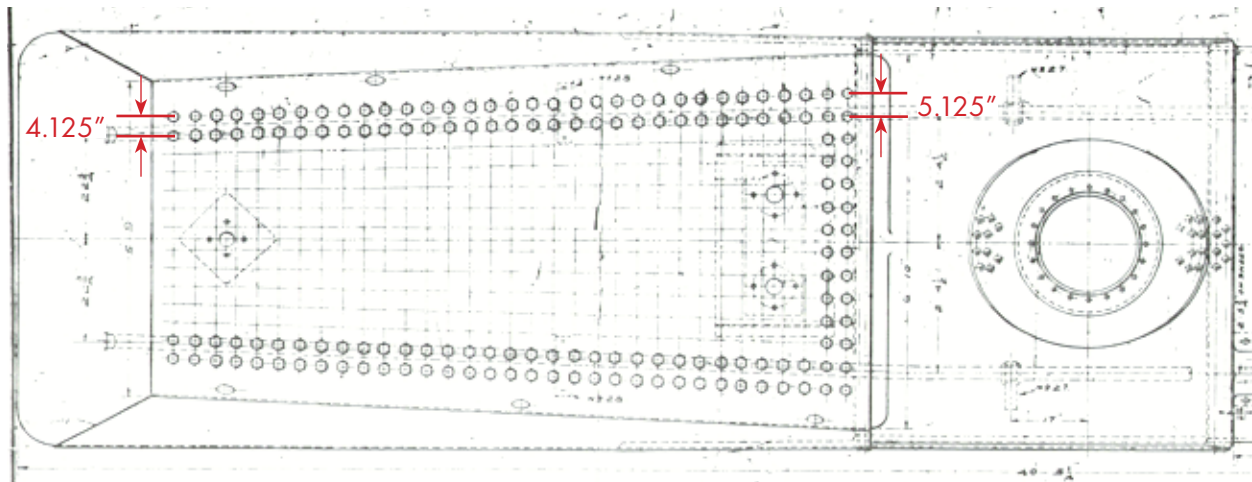
As part of the FMW engineering analyses, the area of greatest concern when reviewing the boiler of No. 1361 is the relation of the crown sheet to the roof sheet. In particular, the spacing of the roof stays increases transversely from the rear of the boiler to the front, due to the tapered geometry of the crown / roof sheet. An engineering drawing of the firebox is shown below that outlines the increased transverse bolt spacing from back to front:

Careful study of the original drawings revealed that just as the roof sheet tapers from its widest at the hip to its narrowest at the back head [SEE PAGE 23], so too do the crown stays taper in their transverse spacing. This means that approximately 35% of the original 7/8 inch rigid staybolts would have internal stresses above the permitted limit of 7,500 PSI. FMW notes that this limit was well established in ASME, ICC, and manufacturer practices of the time (as well as is currently used in 49 CFR § 230), and our hypothesis is that PRR (improperly) utilized average staybolt spacing in its calculations to permit the use of smaller diameter staybolts.

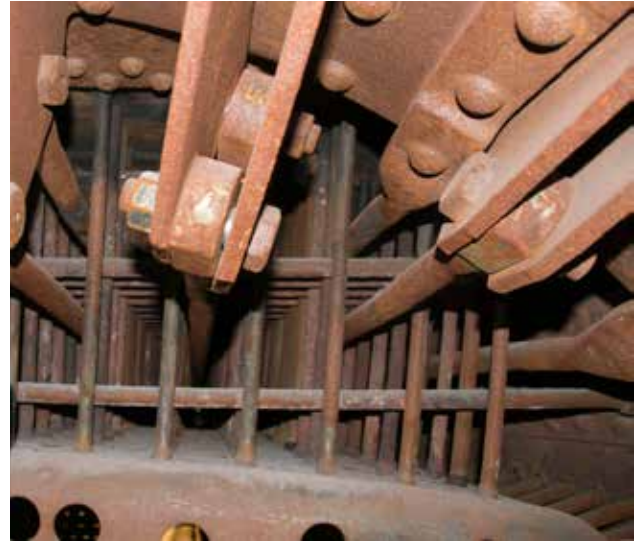
The BELPAIRE firebox design, with the complex array of staybolts and cross stays between the crown sheet and roof sheet, make it impractical to use the typical arrangement of back head braces that extend between the top of the back head and the wrapper sheet and/or top of the adjacent boiler course. Due to the geometric constraints, these back head braces are, instead, connected to brace brackets (“brackets”) that hang down from the top of the third boiler course. These brackets enable the braces to extend at a shallow enough angle to avoid contact with the various rows of cross stays. There are four designs of non-standard backhead brackets included on No. 1361, known as brackets “AA,” “BC,” “EF,” and “G.”

This complex arrangement is shown AT RIGHT. The rear flue sheet and crown sheet are shown at bottom. The crown staybolts are in a vertical array, and the cross stays are the two horizontal rows of steel rods. The two rows of back braces are snaked between the “grid” established by the crown and cross stay bolts. The brackets to which those braces are attached, however, are non-standard boiler design features.

To ensure the brackets meet compliance, FMW has engineered a series of fixes that replace some of the brackets entirely, or modifies existing brackets to increase their safety factor. FEA analysis of each proposed repair are included as follows.

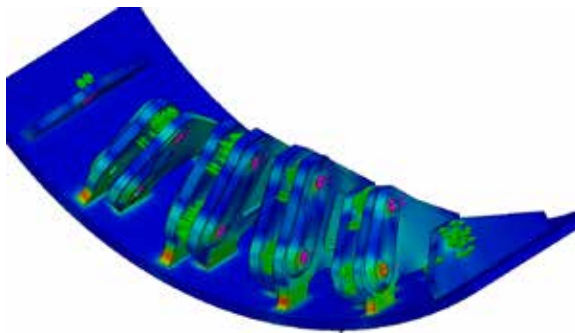
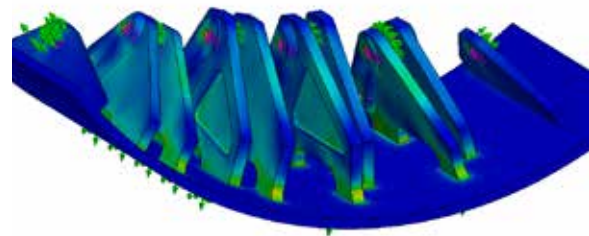
The following graphics [BELOW] show the combined weldments that will replace brackets AA, BC, and EF. The outer two most brackets are the two “G” brackets, discussed below.

Brackets AA, BC, and EF are to be replaced with a series of weldments of thicker material. These weldments are to be made of a comparable steel to the boiler barrel (e.g. SA516-60) and will be attached via accepted welding practice.

- Modifications / replacements to be made to brackets AA, BC, EF and G
- Remove brackets AA, BC, and EF, plug weld the rivet holes in accordance with flush patch repair protocol per 49 CFR § 230.33(b)&(d)
- Replace bracket AA, BC, and EF with thicker material of SA516-60, or similar, material
- Modify bracket G to add stiffening ring, per Section 3.3 of this report
- Reinstall brackets with rivets and/or weldment, as applicable
